FACILITY STATUS CHANGE FORM

Date Submitted: Feb 21, 2013 Originator: David Warren Phone: 539-6040	Area: 100-N Facility ID: 105-NA and 1722-N Action Memorandum: 100-N Ancillary Facilities	Control #: D4-100N-0048
---	--	-----------------------------------

105-NA Emergency Diesel Enclosure & 1722-N Decontamination Building Completion

100-N ANCILLARY FACILITIES REMOVAL ACTION SAMPLING DETERMINATION FORM

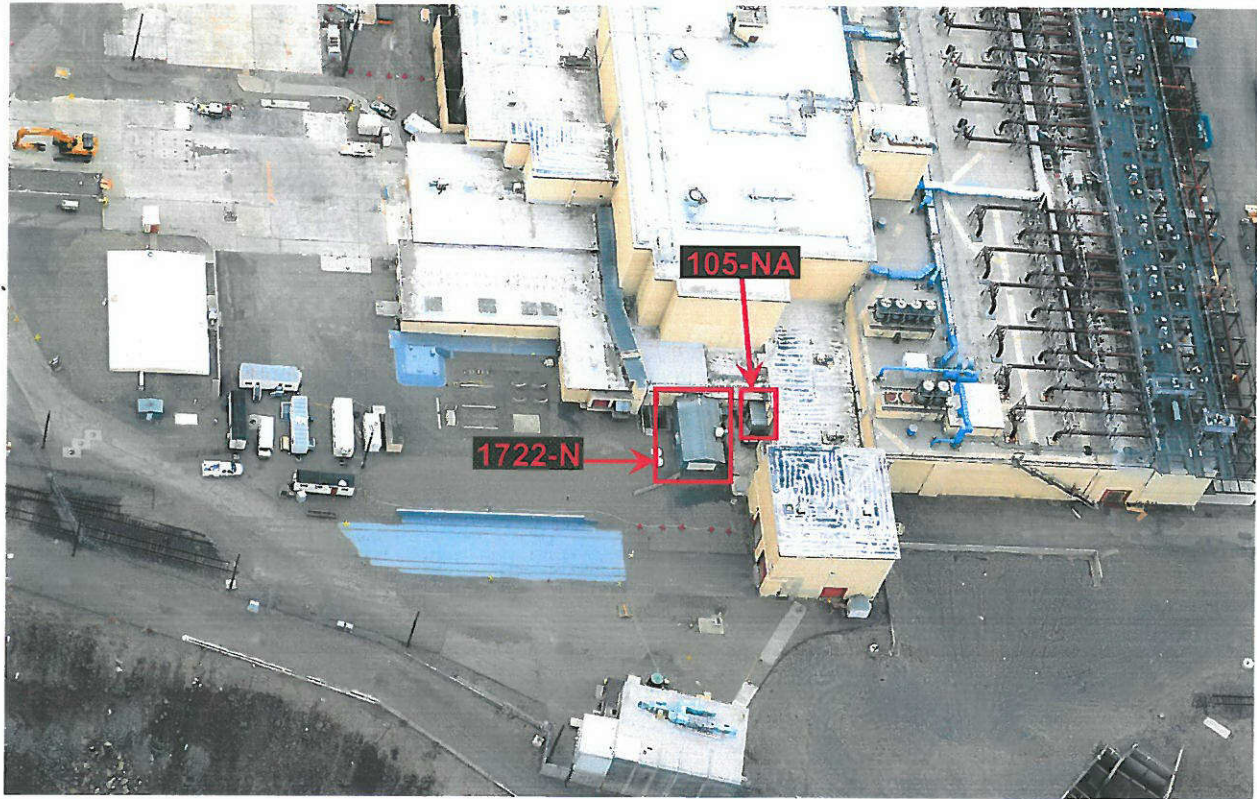
105-NA & 1722-N Pre-Demolition

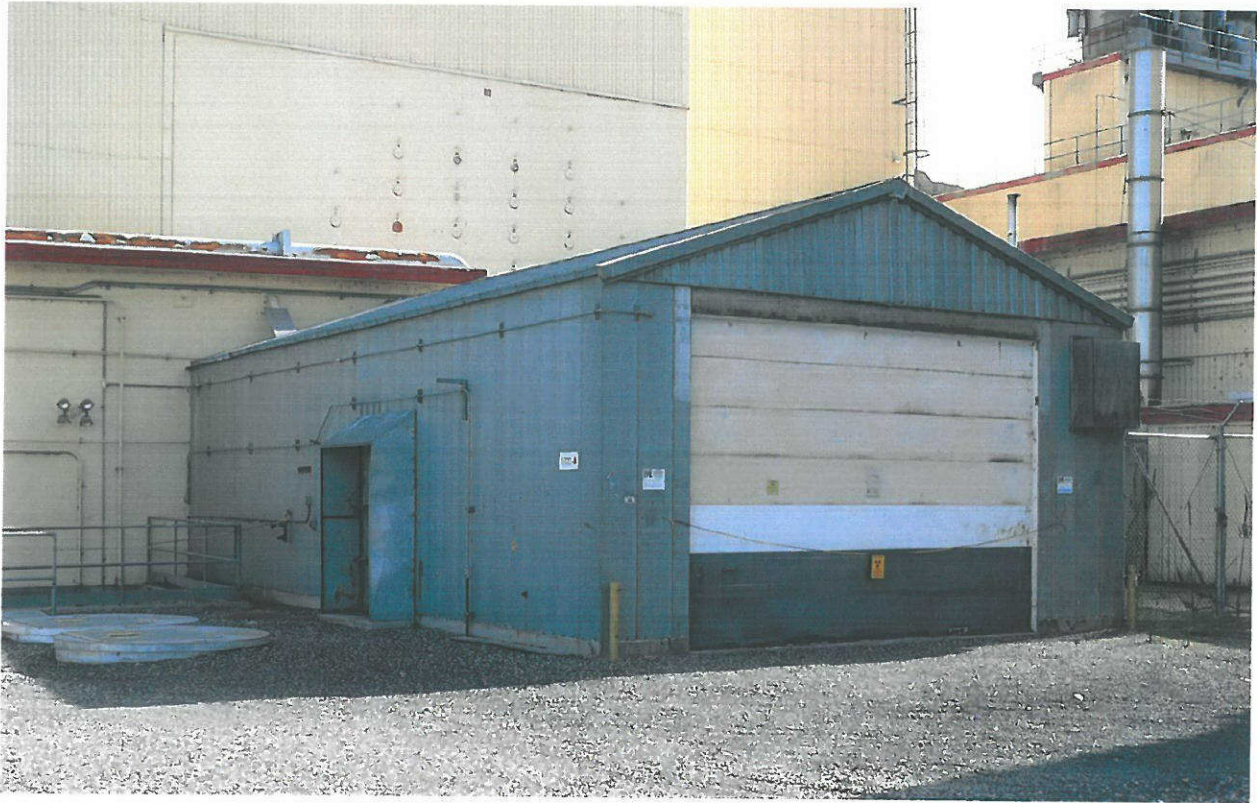
1722-N Pre-Demolition

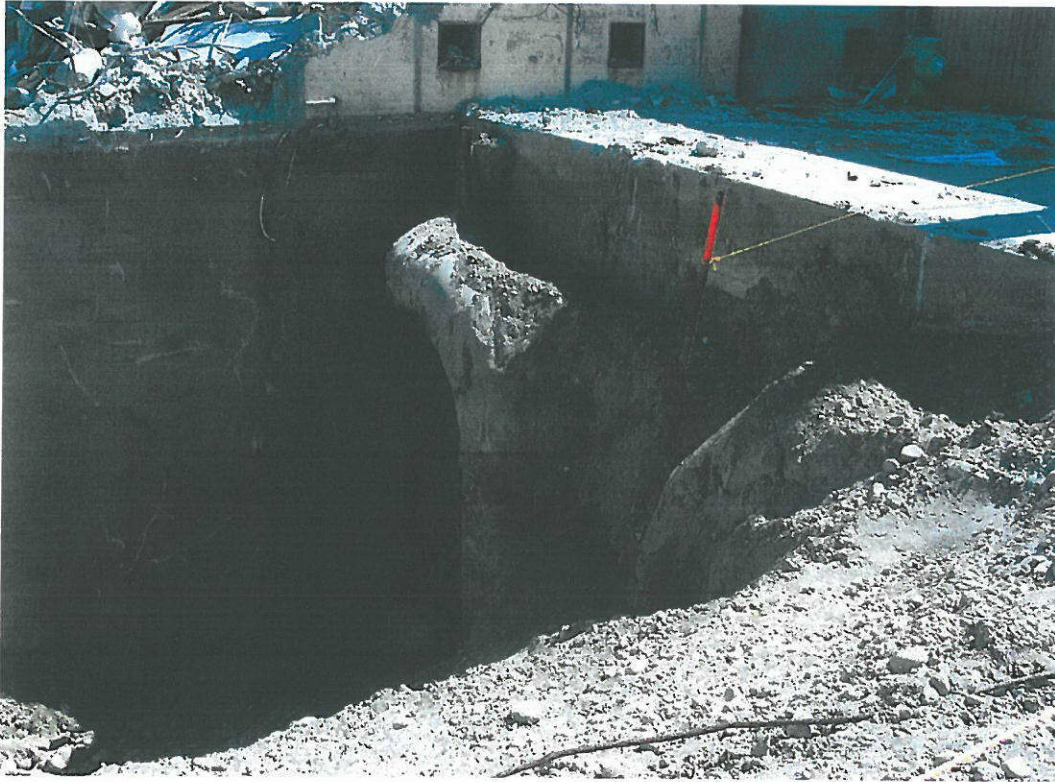
105-NA & 1722-N Post-Demolition
